Docket No. 217 – Development and Management Plan Inspection

Northeast Utilities Service Company Certificate of Environmental Compatibility and Public Need for the construction of a 345-kV electric transmission line and reconstruction of an existing 115-kV electric transmission line between Connecticut Light and Power Company's Plumtree Substation in Bethel, through the towns of Redding, Weston, and Wilton, and to the Norwalk Substation in Norwalk, Connecticut.

Date: September 13, 2006

Location: 345kV XLPE Component

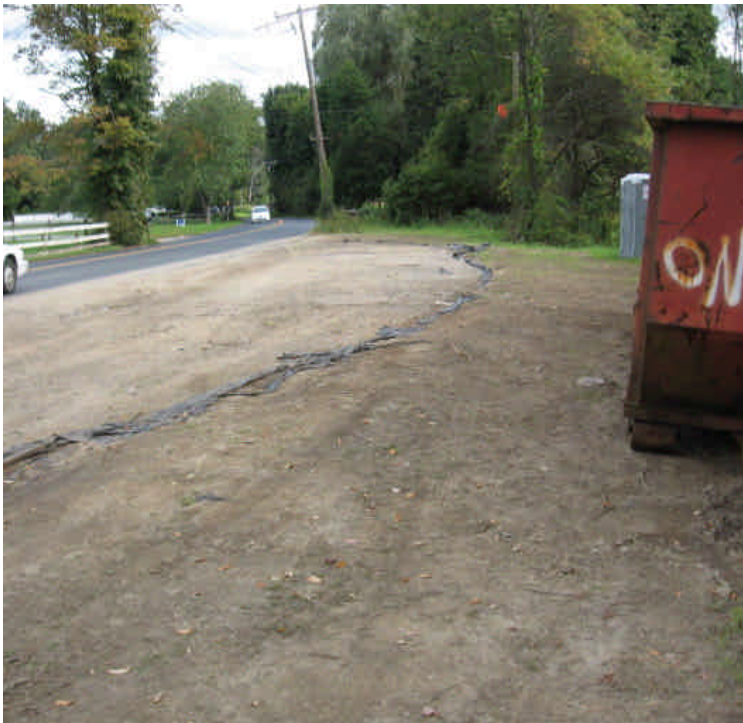
345kV XLPE: Photo on the left shows vault #2 where silt fence is down and the previously established vegetation has died-off due to the heavy traffic and parking in the area. Photo on the right shows what appears to be a concrete washout left behind at the vault. The area needs further restoration. 9/13/06

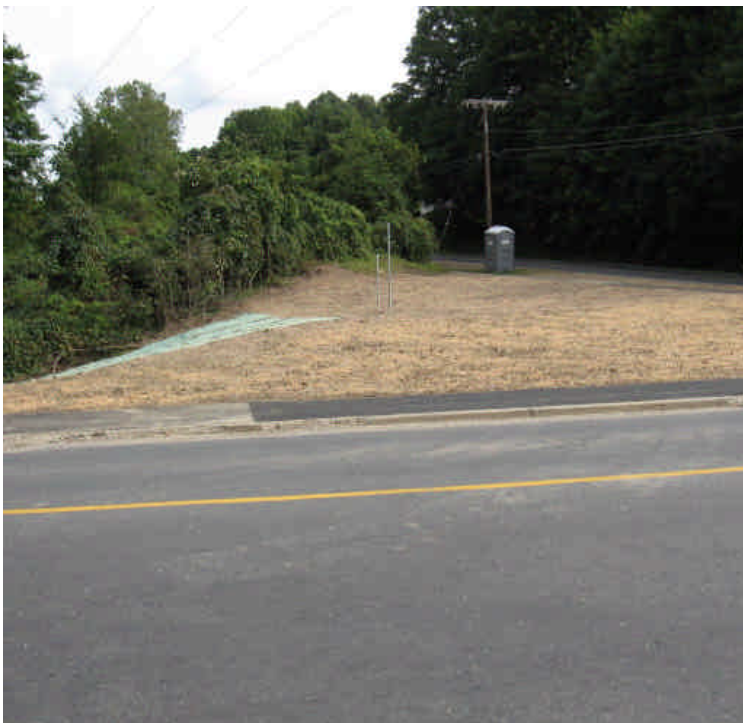
Photo on the left shows the jacking pit at the jack & bore following restoration. The area has been graded , seeded, and mulched. The sidewalk was also repaired. Photo on the right shows a section of erosion control matting installed along the restored slope to prevent washouts. 9/13/06

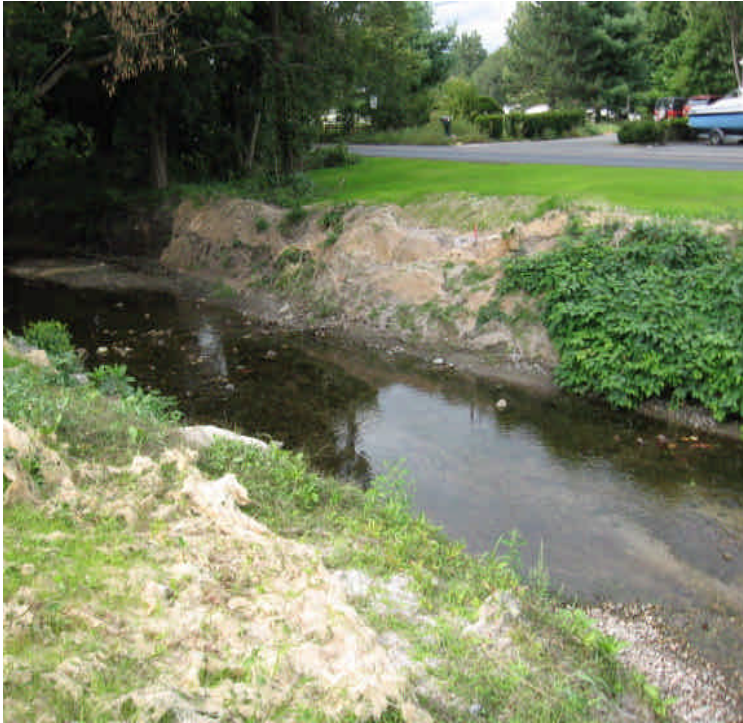
Photo on the left shows the streambank with patchy vegetation returning. Additional seed or cover may be necessary prior to the end of the growing season. Photo on the right shows the restored area in the ball-park with grass cover establishing. 9/13/06

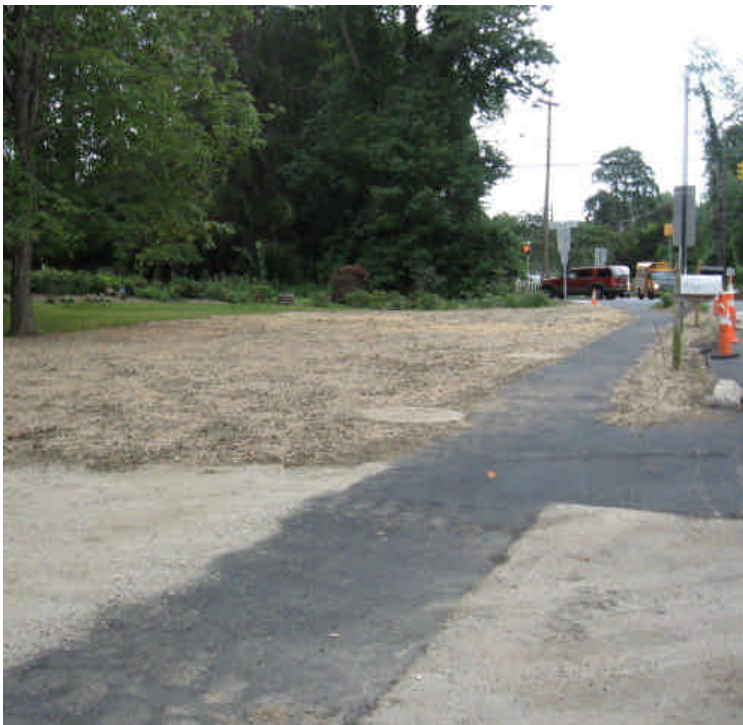
Photo on the left shows vault #5 which has recently been restored with seed and mulch. Photo on the right shows the restored wetland area off Rt 58 which continues to revegetate well. 9/13/06
